# Last Chance Grade Permanent Restoration Project

## Preliminary Geotechnical Report

Submittal SUB-051

EA# 01-0F280  
Project EFIS# 0115000099  
Del Norte County, U.S. 101,  
PM 12.7/16.5

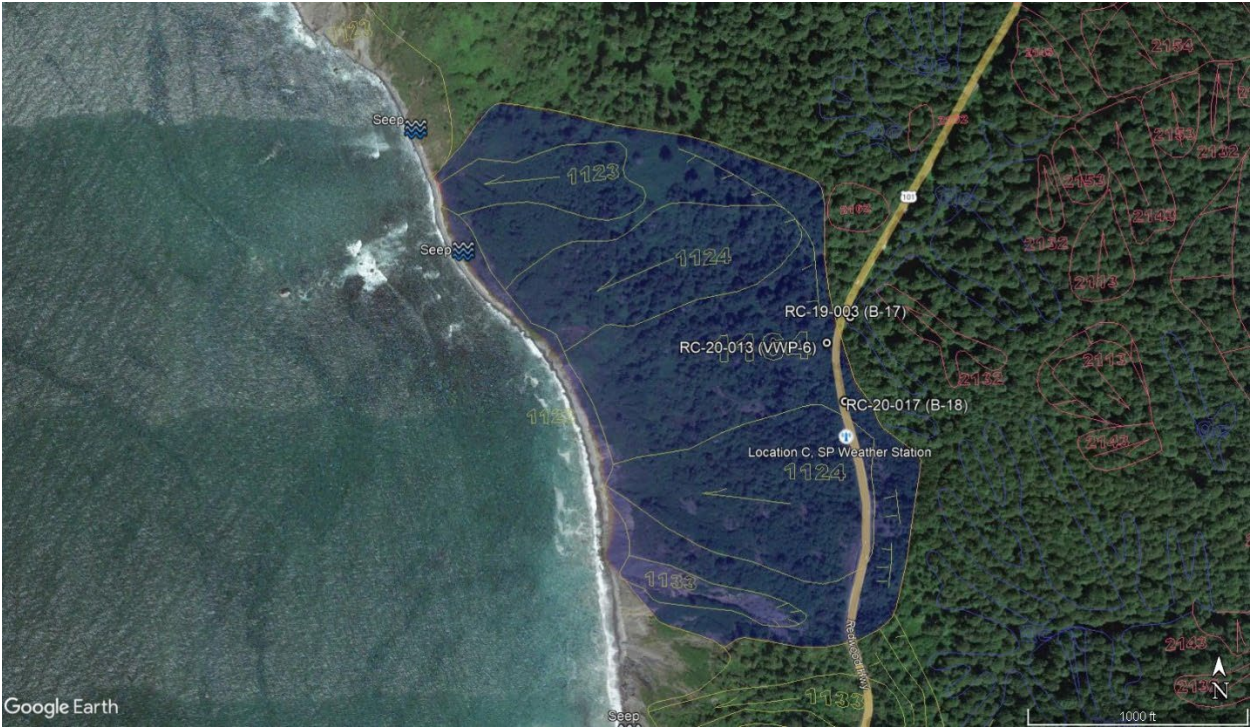
Figure 3. Location of NLCG with VLPs, Springs/Seeps and Weather Station C

Three VWP's were installed near the head of the NLCG landslide (Figure 3). VWP's RC-20-013 and RC-20-017 are located within the landslide mass of the NLCG and RC-19-003 is located approximately 100 feet away from the slide. Each of the transducers in VWP's RC-20-013 and RC-20-017 are located below the failure surface of the NLCG and each have measured groundwater at an apparent elevation below the landslide, suggesting that the landslide mass in the head scarp area may be unsaturated. There may also be low hydraulic connection with fractures in the underlying bedrock, which can be evaluated by collecting more site-specific data. An abrupt drop in apparent groundwater elevation between VWP RC-19-003 (Figure 4) and VWP RC-20-013 (Figure 5) suggests a possible discontinuity, or barrier, between the two locations. The NLCG failure surface (back-scarp) between VWP RC-19-003 and VWP RC-20-013 could have rapid hydraulic connection to local recharge. Although there is no groundwater monitoring within the western part of the slide mass, it is reasonable to assume rainfall onto the NLCG west of the highway has infiltrated into the fractures of the slide.

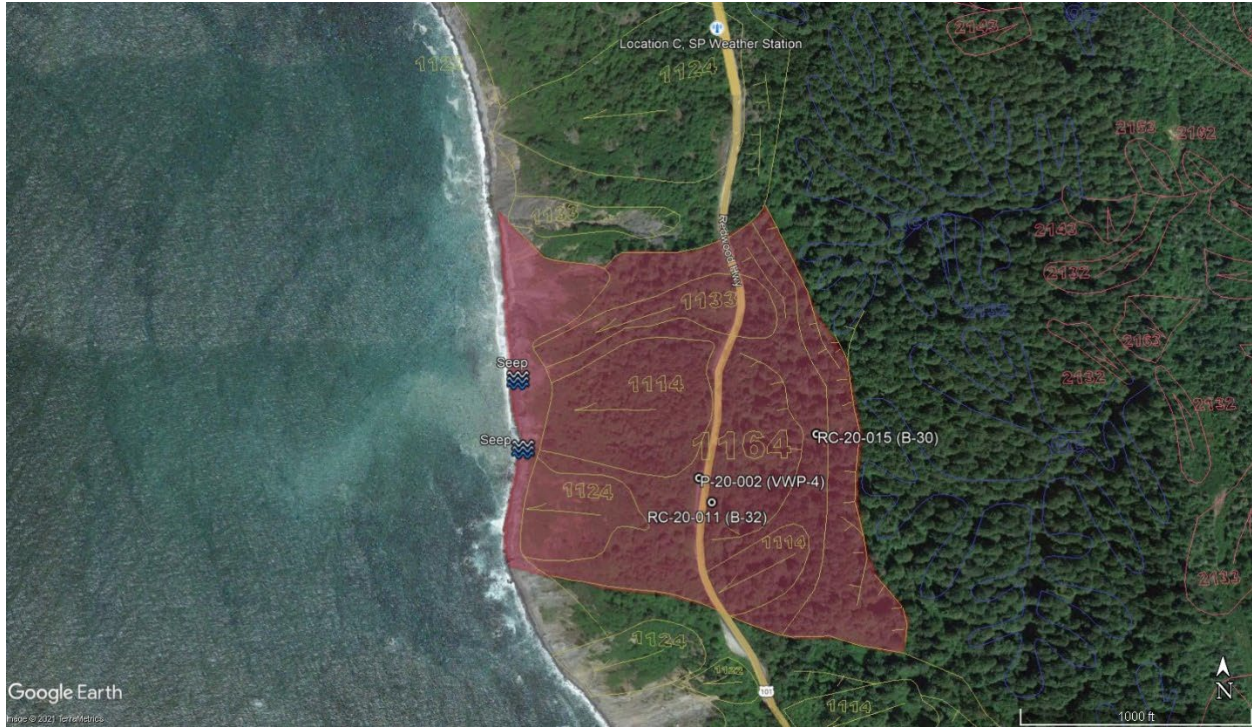
Figure 6. Location of SLCG with VWP, Springs/Seeps and Weather Station C

Three VWPs are located within the landslide mass of the SLCG (Figure 6). VWPs P-20-002, RC-20-011, and RC-20-015 are located in the middle and upper part of the landslide near the head scarp. The transducers in VWP RC-20-015 are located below the failure surface of the SLCG; however, the transducers in VWPs RC-20-011 and P-20-002 are located above and below the landslide failure surface (Figure 6). VWP RC-20-015 is located near the head of the landslide with measured groundwater at an apparent elevation below the landslide in the two lower transducers. The shallowest transducer located near the base of the landslide measures very shallow to no groundwater present, suggesting that the landslide mass in the head scarp area may be mostly unsaturated. The remaining two VWPs, RC-20-011, and P-20-002, are located approximately 100 feet from each other near the middle of the SLCG. The VWPs measure apparent groundwater elevations from 485.3 to 736.7 feet (Table 5). Groundwater elevations indicate a downward vertical gradient at each location.

As seen on Figure 7, response to rainfall is noticeable in the two lower transducer signatures of VWP RC-20-011 but not the uppermost transducer located at a depth of 144 feet, which may not be under saturated conditions. Springs/seeps mapped along the bluff face near the beach (Figure 6) emanate from the sandstone and argillite bedding and fractures at about 1 gallon/minute (visual observation). These springs/seeps are draining groundwater from the landslide mass and/or the underlying Broken Formation.

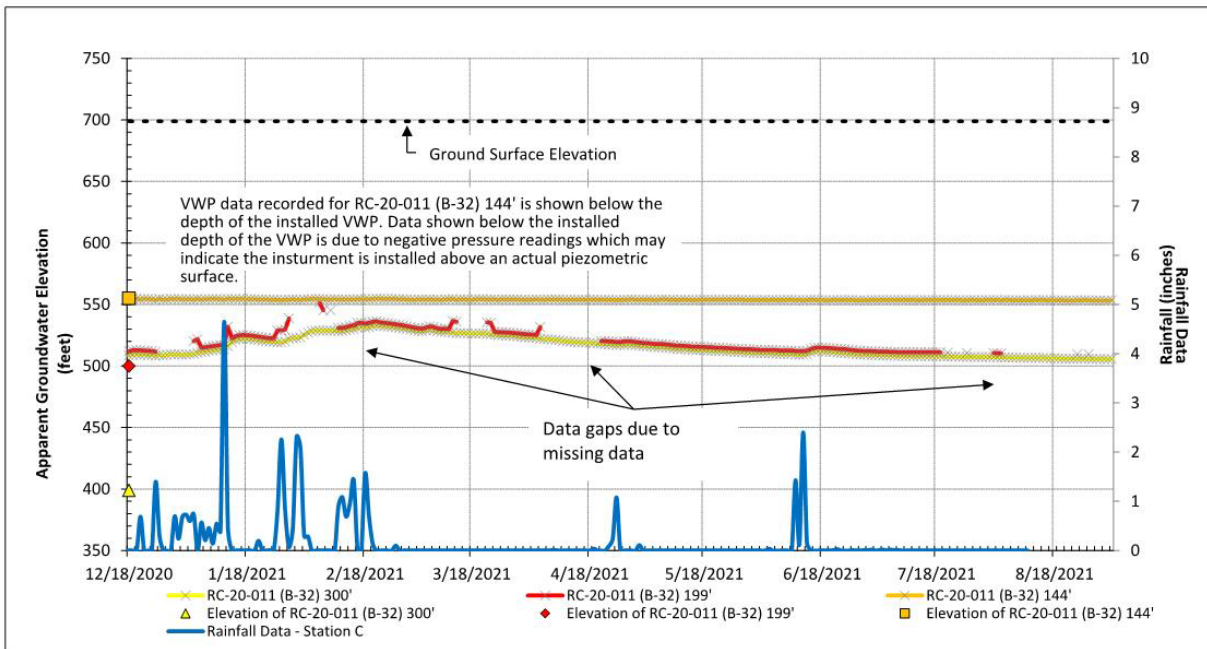
Figure 7. VWP RC-20-011 Hydrograph Showing Multiple Transducers and Rainfall

November 9, 2021  
VWP Hydrograph  
Bore Hole RC-20-011 (B-32)

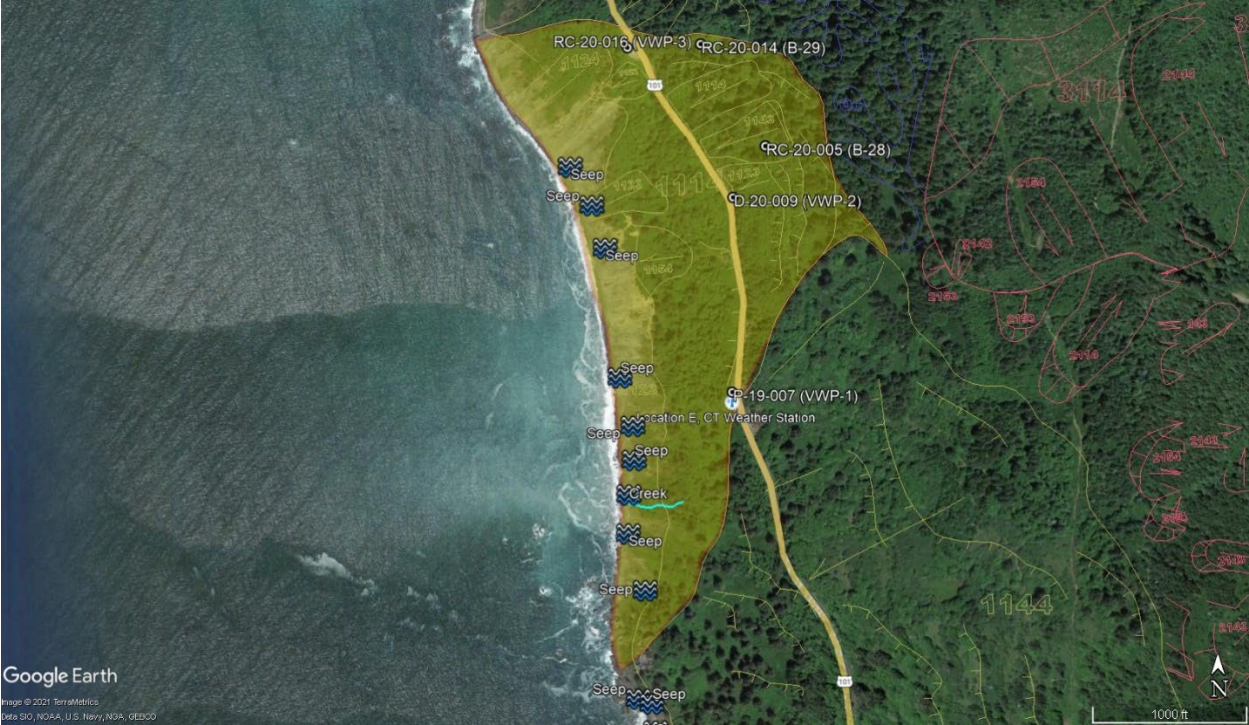
Figure 8. Location of WC with VWPs, Springs/Seeps and Weather Station E

Five VWPs (P-19-007, RC-20-005, D-20-009, RC-20-014, and RC-20-016) were installed near the head of the WC landslide and along its northern and southern boundary (Figure 8). Multiple transducers were installed in the VWPs at various depths above and below the failure surface of the WC (Figure 8). The transducers in the VWPs have measured groundwater at numerous apparent elevations throughout the landslide mass and the underlying bedrock. The groundwater appears to be unconfined to locally confined and occurring in the fractures within the landslide and underlying Broken Formation (based on boring logs). VWP D-20-009 provides an example of an upward vertical hydraulic gradient in the WC landslide that may indicate locally confined conditions (Figure 9). The measured hydrostatic head at deepest transducer (depth 260 feet) has been generally above that measured by the two shallower transducers at depths of 95 feet and 195 feet. However, starting in August 2021, the apparent groundwater elevation measured by the deepest transducer dropped below that of the shallow transducer but recovered above this elevation by late 2021.

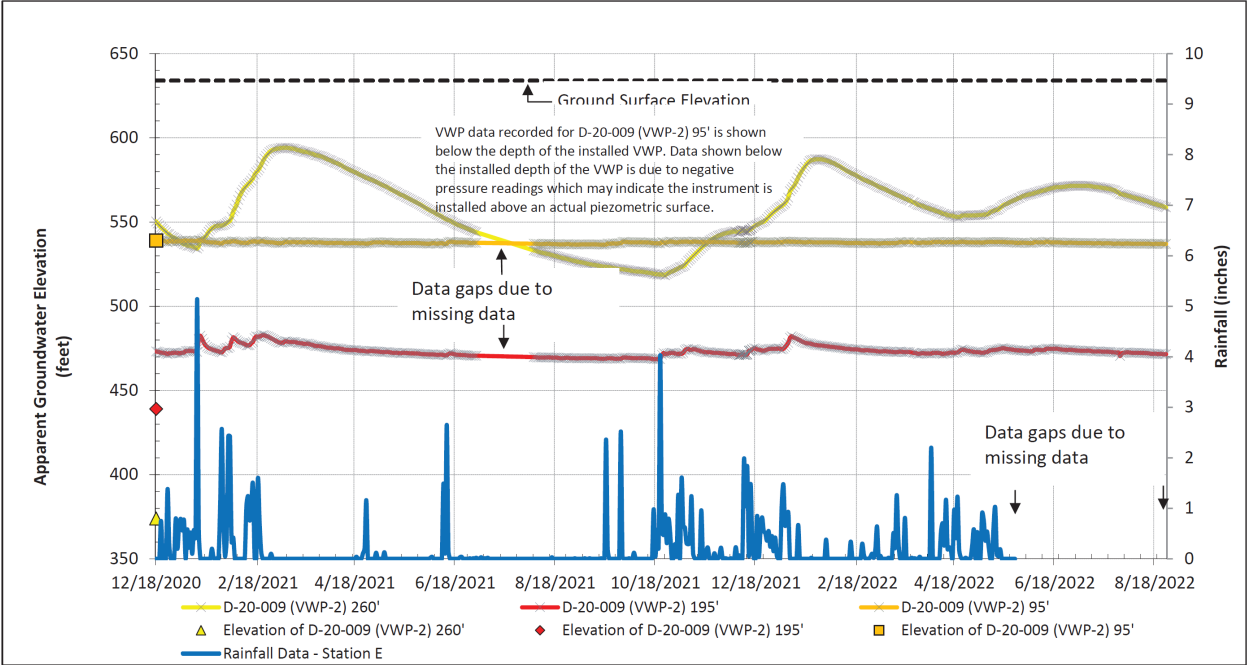
Figure 9. VWP D-20-009 Hydrograph Showing Multiple Transducers and Rainfall

Infiltration of rainfall into the groundwater system is noticeable in the lower two transducer signatures of VWP D-20-009, as seen in Figure 9, while there is negligible response to rainfall in the shallowest transducer signature, which may not be under saturated conditions. Seasonal effects are also apparent in the response of the deepest VWP (260 feet) with a more subdued seasonal response in the 195-foot-deep VWP. Springs/seeps mapped along the bluff face near the beach (Figure 8) emanate from the sandstone and argillite bedding and fractures at 1 to 50 gallons per minute (visual observation).

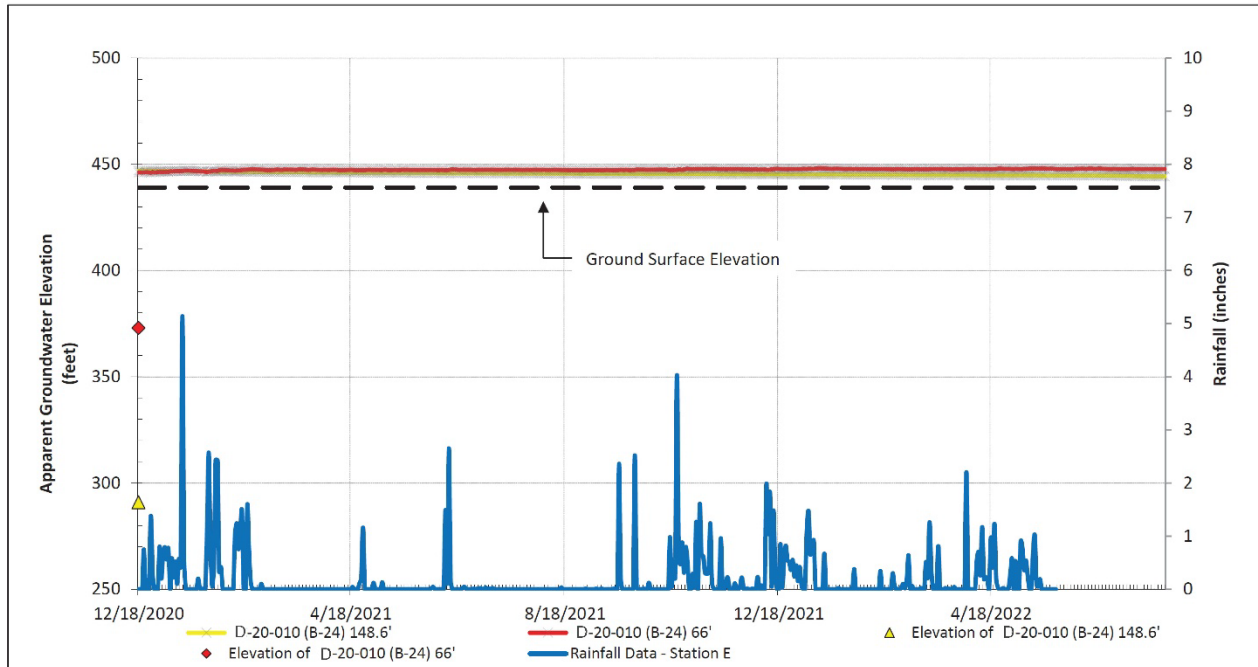
**Figure 13. VWP D-20-010 Hydrograph Showing Multiple Transducers and Rainfall**

Other groundwater measurements in the EF VWPs also indicate that the groundwater is locally confined. For example, both transducers at VWP D-20-010 have measured apparent groundwater elevations 8.3 to 10.1 feet above the ground surface. Since no manifestation of surface discharge has been identified, the groundwater may be confined, and groundwater tapped at the depth of these transducers might manifest with artesian conditions. Apparent groundwater elevations are similar at the two transducers, one at the base of the landslide and one below the failure surface (Figure 13). These similar apparent groundwater elevations also indicate the fracture systems influencing the two transducers may be hydraulically connected.

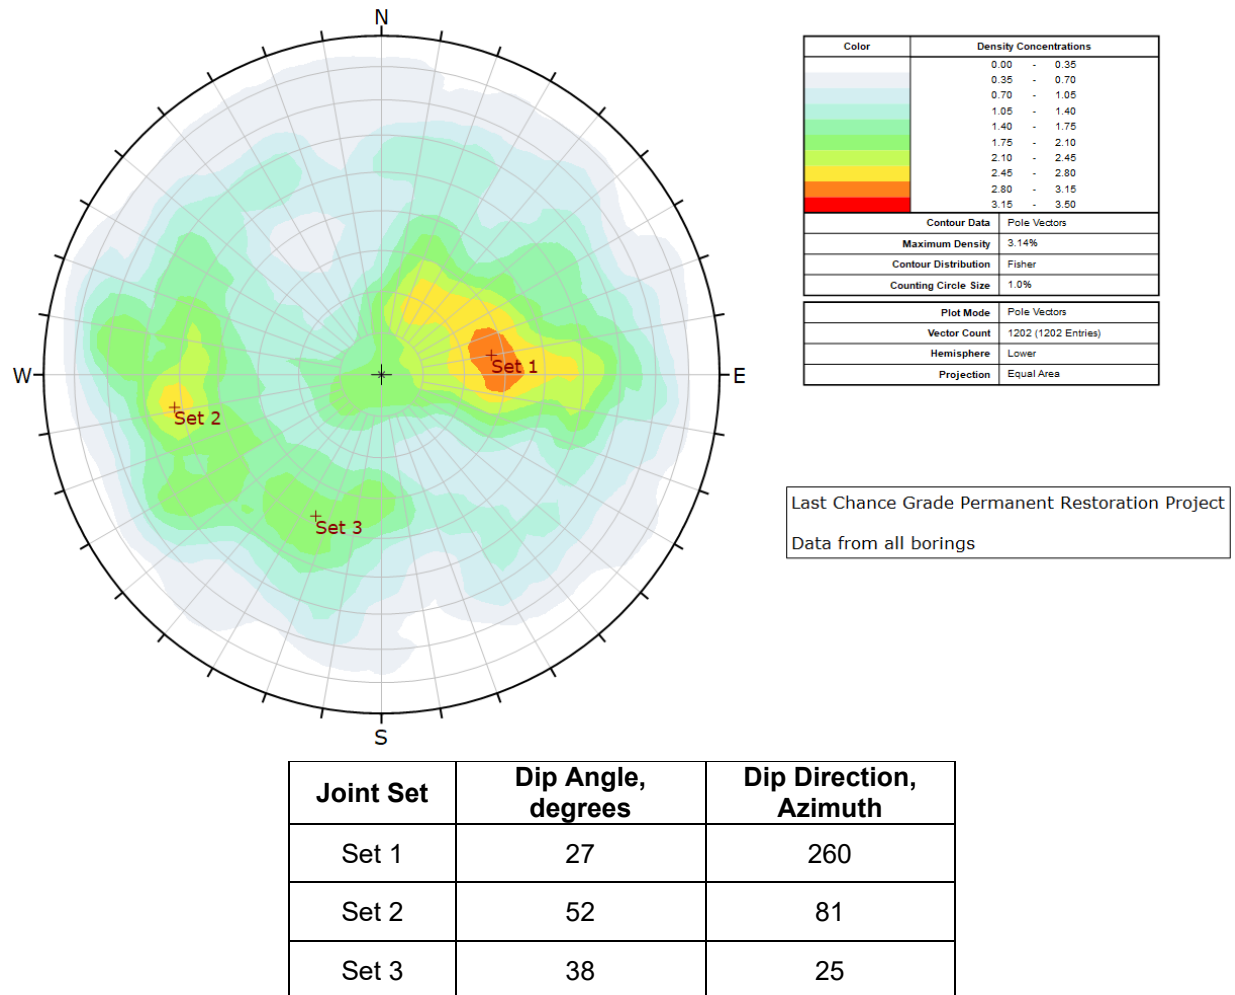
**Figure 15. Orientation of Fractures and Joint Sets.**

The limited ATV and OTV data from downhole logging of seven boreholes suggest that some identifiable joint sets are present. Figure 15 presents a DIPS-generated (Rocscience, 2021a) lower-hemisphere equal area stereonet plot of poles to 1202 discontinuities logged in Borings RC-20-005, RC-20-011, RC-20-014, RC-20-016, RC-20-017, RC-20-019, and RC-21-001. Three joint sets were identified in this global plot and are listed in order of decreasing pole concentrations in Figure 15.

1. ATV/OTV data are from Borings RC-20-005, RC-20-011, RC-20-014, RC-20-016, RC-20-017, RC-20-019, and RC-21-001, as presented in July 2022 Final Preliminary Geotechnical Data Report (Caltrans, 2022a).
2. Poles per 1 percent stereonet area were counted and contoured using DIPS v.8.011 (Rocscience, 2021a).
3. Orientations of joint sets were defined as the mean plane orientation within a window of pole concentrations identified by cluster analysis using DIPS. In most cases, this orientation is similar to the polar point maximum.

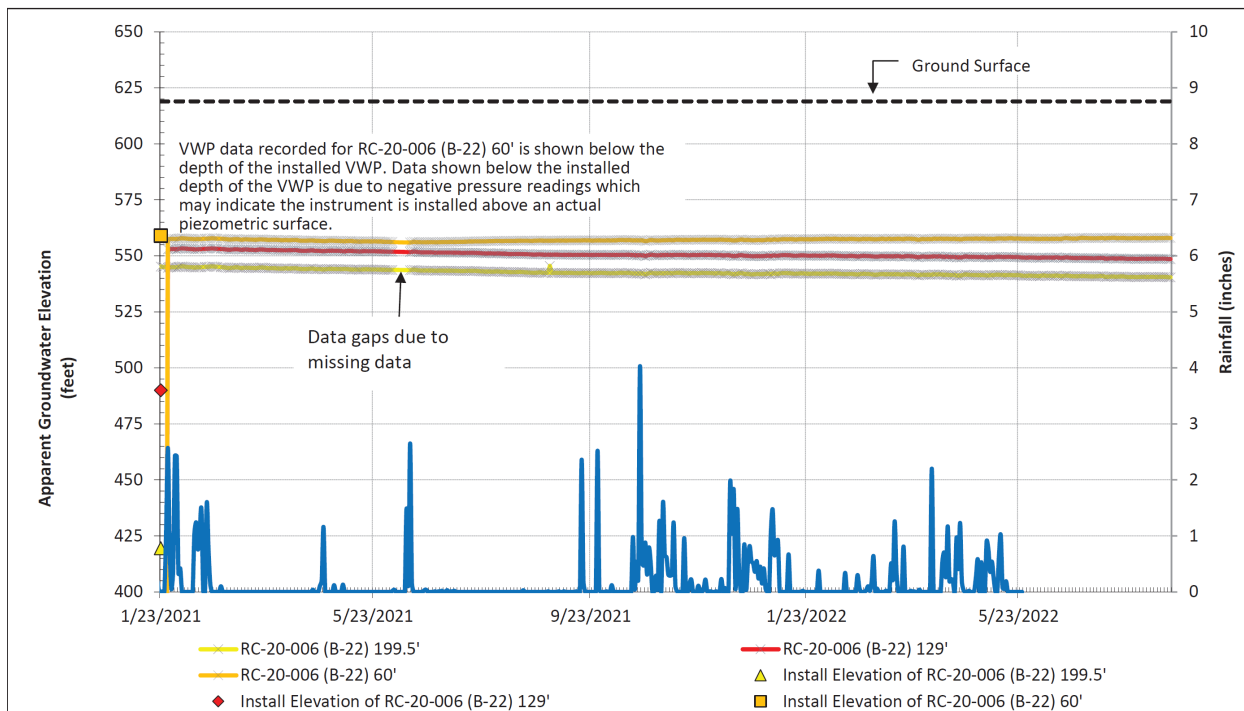
**Figure 16. VWP RC-20-006 Hydrograph Showing Multiple Transducers and Rainfall**

The VWP's selected to evaluate groundwater conditions at the proposed South Portal area and approach were RC-20-019, P-19-007, and RC-20-006. The transducers in RC-20-006 are located above and below the landslide failure surface. The apparent groundwater elevation is expected to be approximately 450 feet near Station 44+50 and approximately 561 feet near the portal. VWP RC-20-006 (Figure 16) shows typical signatures from transducers located below and above the EF landslide mass.

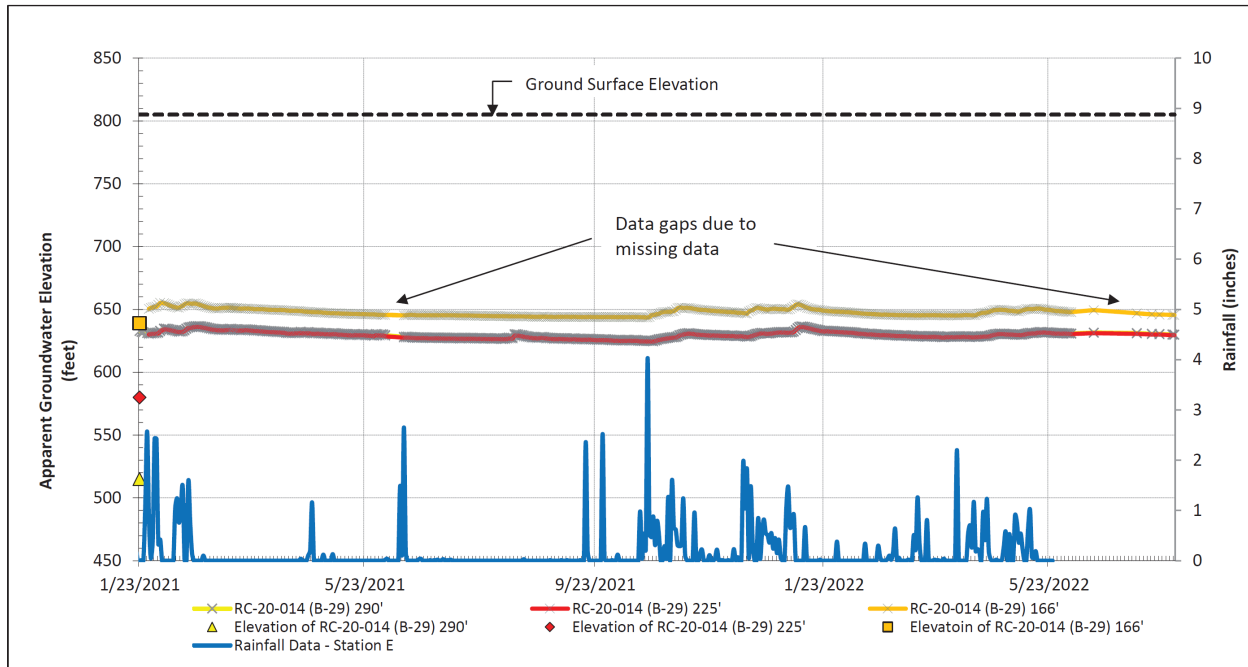
**Figure 17. VWP RC-20-014 Hydrograph Showing Multiple Transducers and Rainfall**

For the portion of the tunnel alignment within the Melange, the groundwater is probably dominated by fracture flow. The data for VWP's at RC-20-014 indicate similar head values for the two deeper VWP's and a small upward gradient at these depths (Figure 17). For the portion of the tunnel alignment within the Broken Formation, VWP's recorded apparent groundwater elevations above and below the alignment.

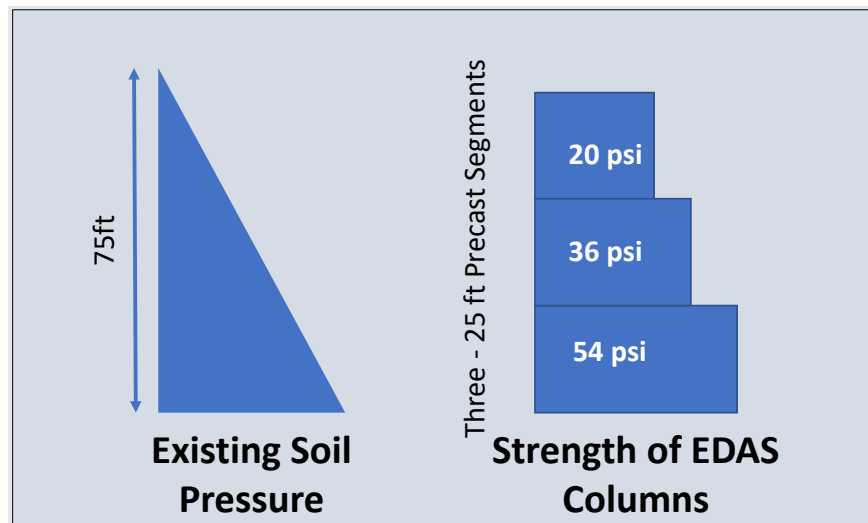
To establish the collapse strength of the columns it was necessary to determine the current earth pressures in the surrounding earthflow soils. Theoretical calculations suggest the corresponding earth pressure coefficient should be approximately 0.74, based on a Coulomb analysis. In-situ pressuremeter tests taken in the earthflow (Caltrans, 2022a) indicate earth pressure coefficients in the range of 0.7 to 0.85. This close correlation between theory and practice provides confirmation and a reasonable level of confidence in the selection of the column strength criteria. For the purposes of this study an earth pressure coefficient of 0.8 was used, and a stepped strength profile was used for modeling, as shown in Figure 28.

**Figure 28. Stepped EDAS Strength Profile**

The required width of the EDAS treatment zone is dependent upon the projected downslope movement of the earthflow over the life of the structure. This movement was established by using an estimated yearly down slope movement that was extended over the service life of the tunnel and the estimated lateral spreading anticipated to occur due to the design seismic event.

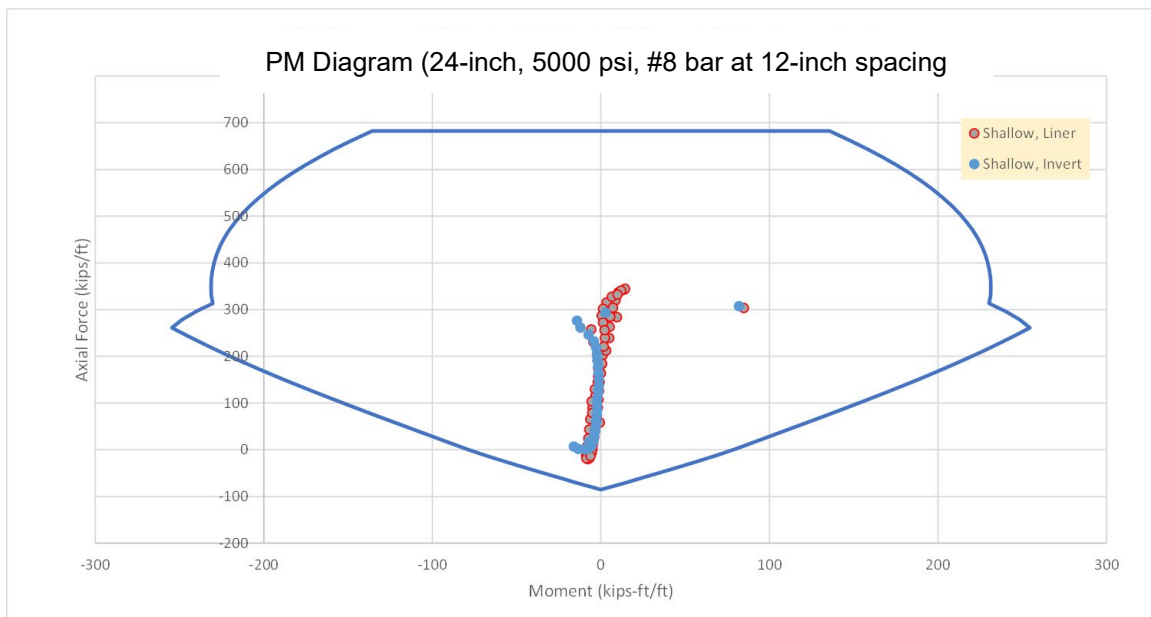
24 inches thick, are well within acceptable limits. Figure 31 and Figure 32 illustrate the stress regime for two cases, a shallow rock case (Reach 3) and a deep rock case (Reach 4). These cases bound the tunnel profile conditions along the alignment. In both cases, the calculated stresses are well within the interaction diagrams meeting the criteria established by ACI-318, shown by blue lines in the figures. These analyses will need to be revisited in more detail as additional subsurface information becomes available and more in-depth modeling can be performed.

**Figure 31. SEM Tunnel in Shallow Rock Cover Condition**

These analyses show that the large, two-lane sequentially excavated tunnel in the Melange would require a robust lining system to survive the design earthquake. Where under more normal loading conditions the lining would be on the order of 16 to 18 inches thick, this tunnel would require a lining thickness of 24 inches. Analysis details are included in Appendix C.

The modes of failure for a tunnel undergoing ground shaking are excessive strains in the lining due to ground-induced shear distortion and overstressing of the lining materials. The preliminary analyses indicated that strains and stresses induced in the proposed lining, currently sized at

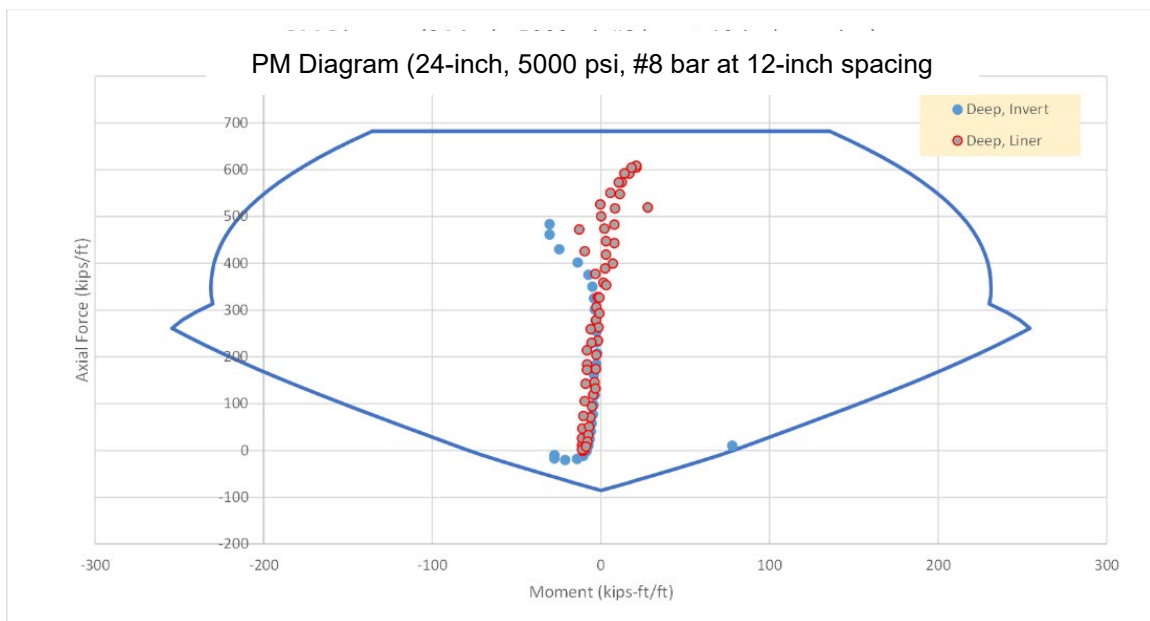
**Figure 32. SEM Tunnel in Deep Rock Cover Condition**

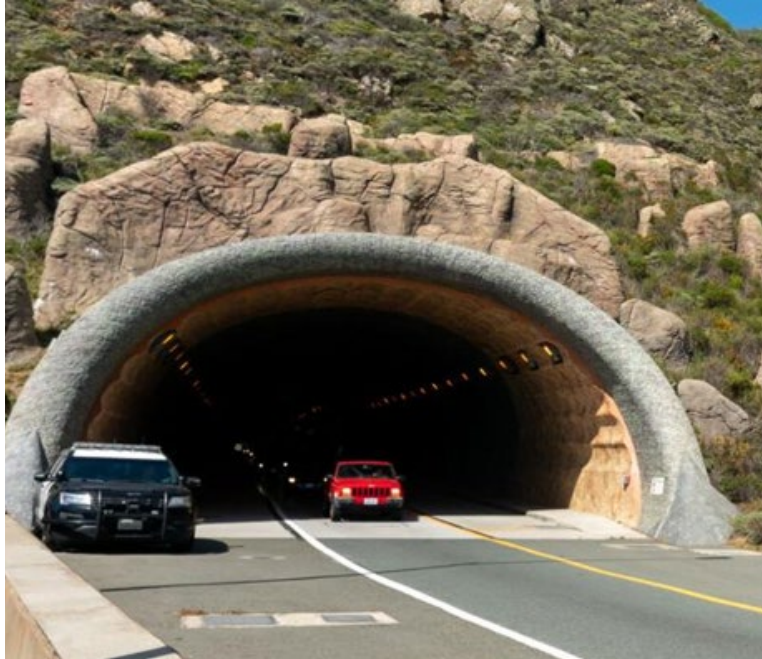
The North Portal headwall would include an architectural arch on the north-sloping rock face. The final portal structure would consist of CIP concrete that is context-sensitive, tinted and textured to blend into the existing geology. A representative example of a context-sensitive portal design is shown in Figure 34. Rockfall protection features, such as a canopy portal extension, would be included at the North Portal.

**Figure 34. Context-Sensitive Portal Design**
