Last Chance Grade Permanent Restoration Project Preliminary Geotechnical Data Report

Submittal SUB#032 July 2022 – FINAL

EA# 01-0F280 Project EFIS# 0115000099 Del Norte County, U.S. 101, PM 12.0/15.5

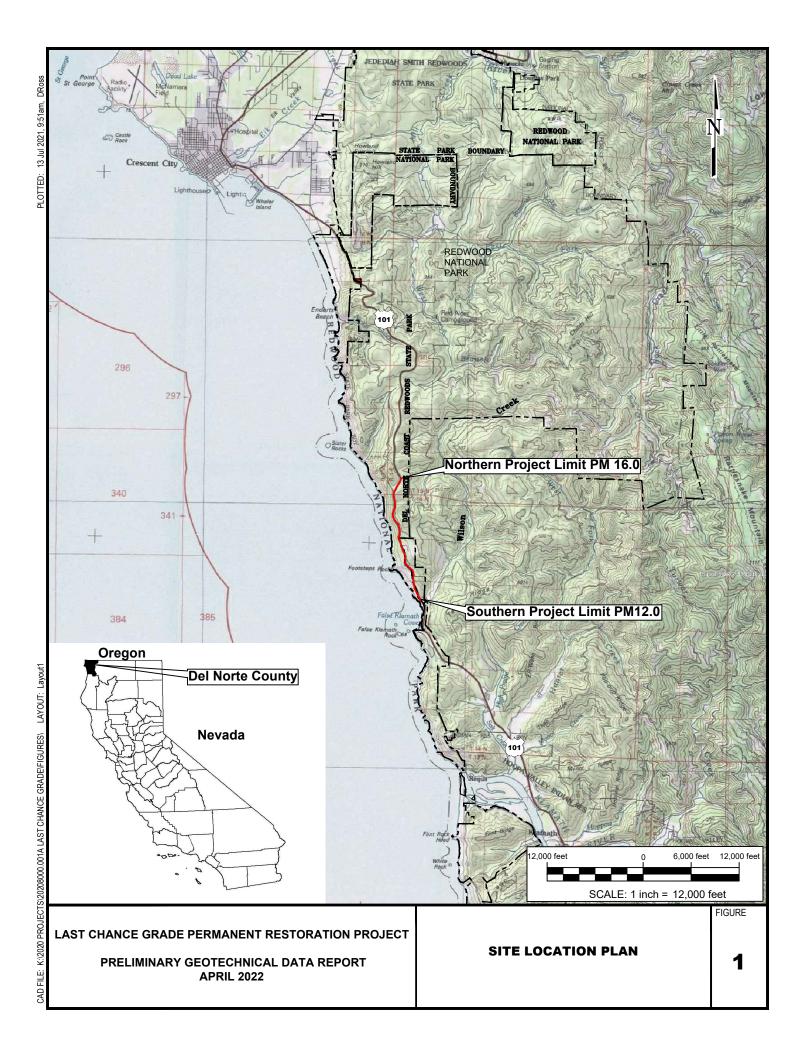
The project area is located within the Coast Ranges geomorphic province of California, near the Klamath Mountains, which lie about 10 miles to the east (see Figure 1). The site is located about 90 miles north of the Mendocino Triple Junction, which is the crustal intersection of the Pacific, North American, and Gorda/Juan de Fuca tectonic plates. North of the triple junction, the Gorda/Juan de Fuca plate is being subducted eastward beneath the North America plate along the Cascadia Subduction Zone (CSZ), which extends approximately 800 miles from northern California to Vancouver Island, British Columbia. As is true for other coastal regions of northern California, Oregon, and Washington, the project site overlies the interface associated with the subducting crustal plate. This subduction interface is a low angle, east-dipping "megathrust" fault.
