APPENDIX A2 *Summary of Phase 1 Geotechnical Investigation* **(Caltrans DES-OGDW, 2018)**

Subject: Summary of Phase 1 Geotechnical Investigation

LAST CHANCE GRADE BYPASS
HIGHWAY 101, POST MILE 13.4/16.0
DEL NORTE COUNTY, CALIFORNIA

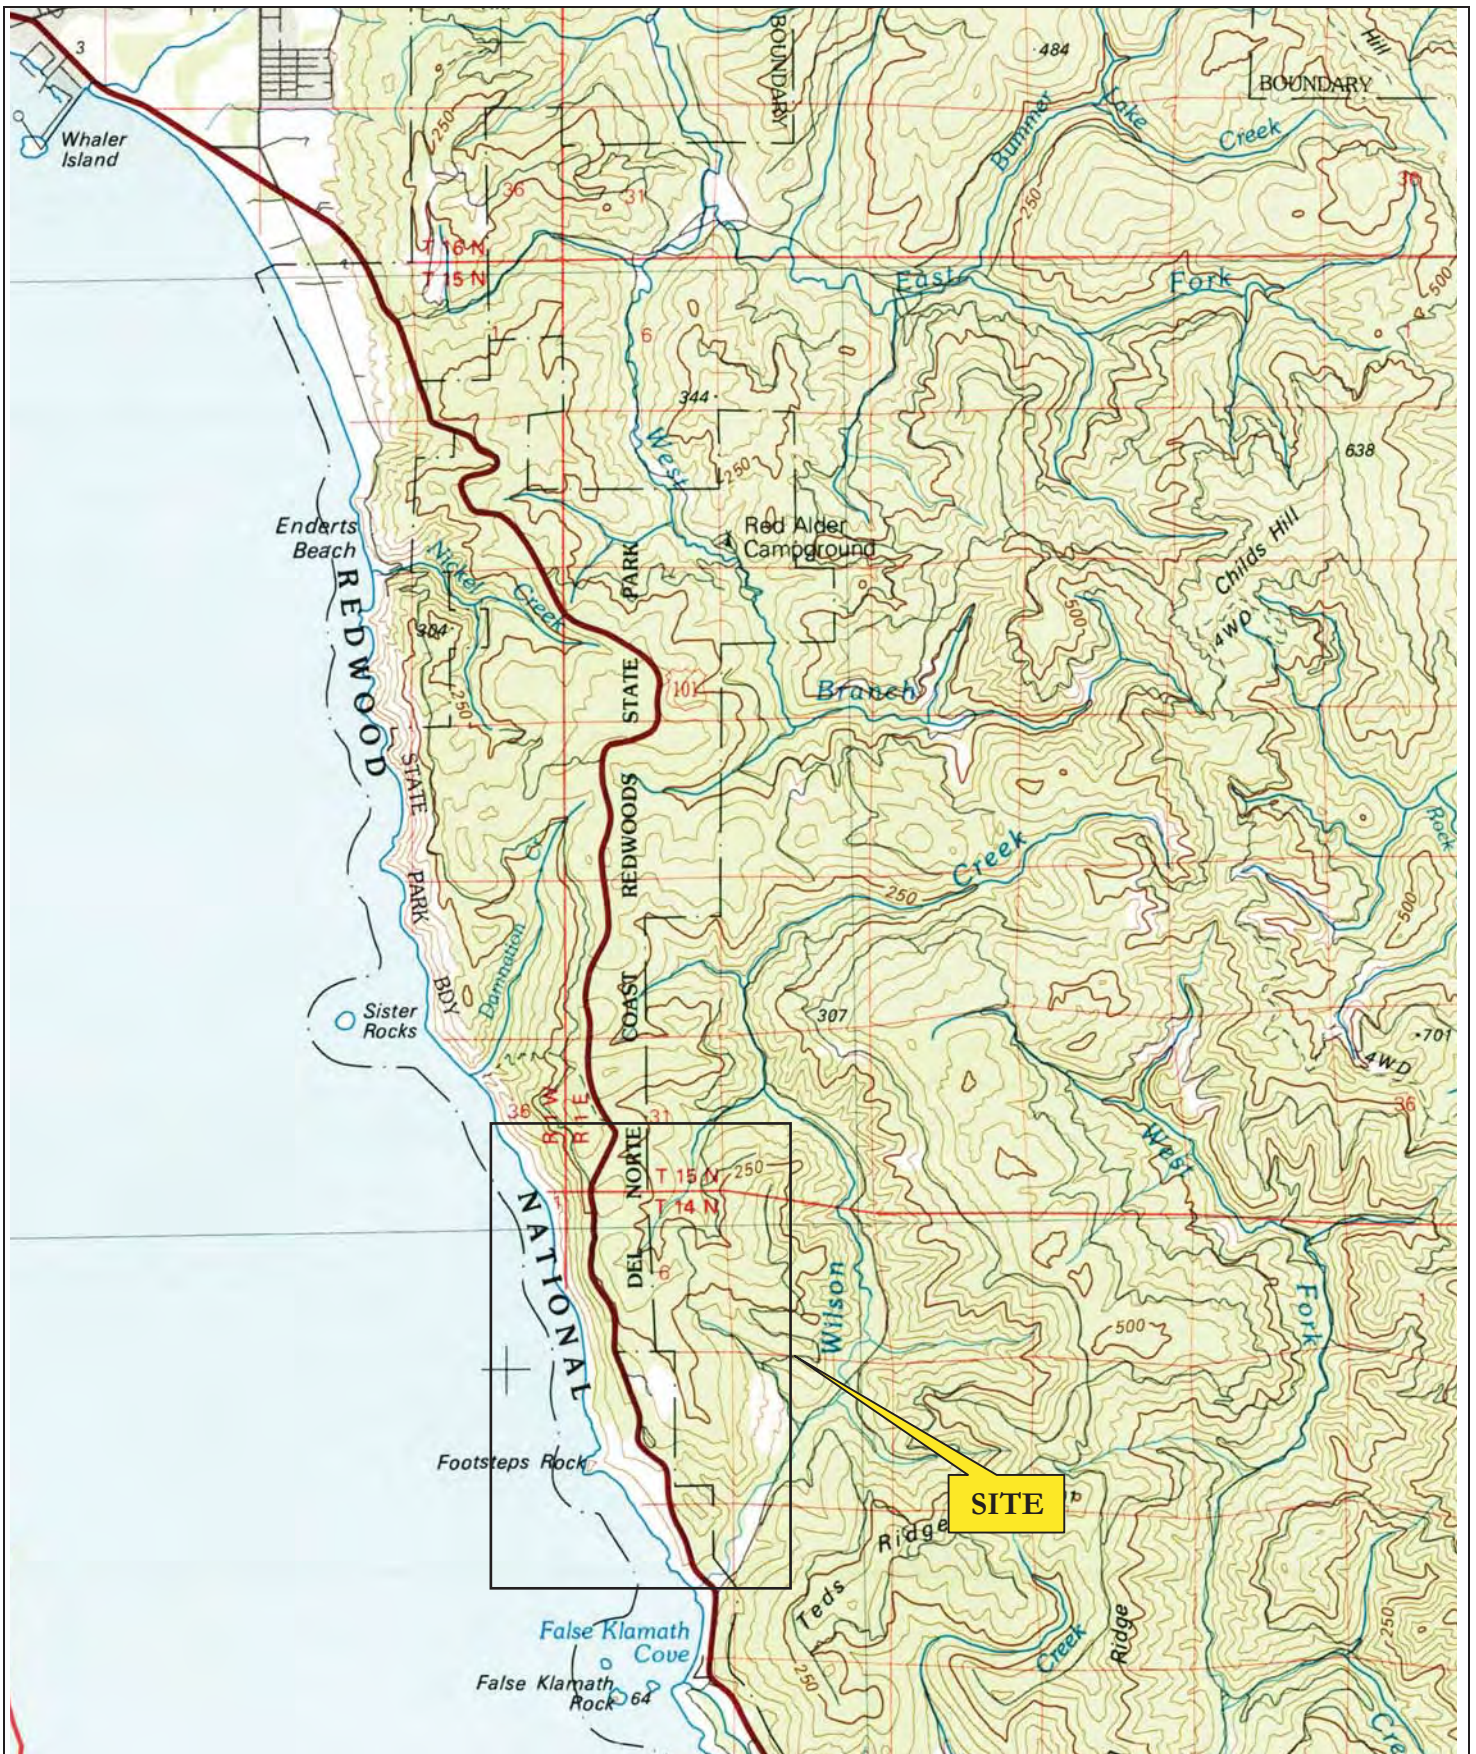
FIGURE 1

SITE VICINITY MAP

Figure 1 – Site Vicinity Map
Figure 2 – Site Plan
Figure 3 – Regional Geologic Map
Figure 4 – Landslide Map
